Queens Transformer Fire Prompts Use of New Technologies

Foam Operations at Queens Box 33-6334

Transformer fire at Queens Box 33-6334, Northern Boulevard/45-08 244th Street, July 24, 2009.

F-500 and its Use at Queens Box 33-6334

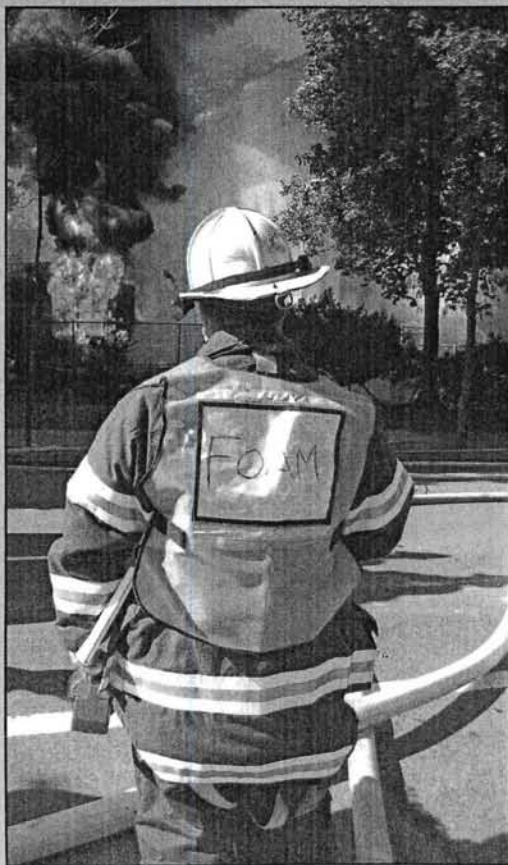
One of the two Foam Coordinators, who supervised operations at this incident.
