Queens Transformer Fire Prompts Use of New Technologies

Foam Operations at Queens Box 33-6334

Transformer fire at Queens Box 33-6334, Northern Boulevard/45-08 244th Street, July 24, 2009.

F-500 and its Use at Queens Box 33-6334

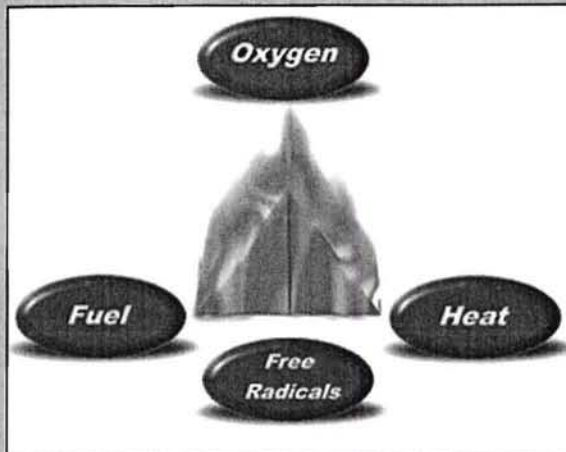
The burning material and surrounding non-combustible materials are cooled below the auto-ignition temperature of the burning material. F-500 acts on individual legs of the fire tetrahedron (see graphic at left) simultaneously. Foam separates the fuel from oxygen by forming a foam blanket. Foam is ineffective on flowing fuel and multi-dimensional fires.

When applied at the proper ratio, F-500 separates the fuel and oxygen by encapsulating the fuel in a chemical cocoon at the molecular level. The encapsulated fuel is neutralized and will not re-ignite even if disturbed. When F-500 was applied at this transformer fire, the fuel and transformer unit and internal oil were cooled. The flowing oil was cooled and neutralized; subsequently, the fire was quickly brought under control.

The unique properties of F-500 have contributed to a number of successful FDNY operations, including multiple transformer fires, combustible metal fires and vapor suppression of flammable/combustible liquids at haz-mat incidents. Incident Commanders should consult with the Haz-Mat Group to see if F-500 can be applied at a given incident. Con Edison currently is testing F-500 for expanded use at its facilities.
